Fatigue failure

Fatigue failures in pumps – part 3

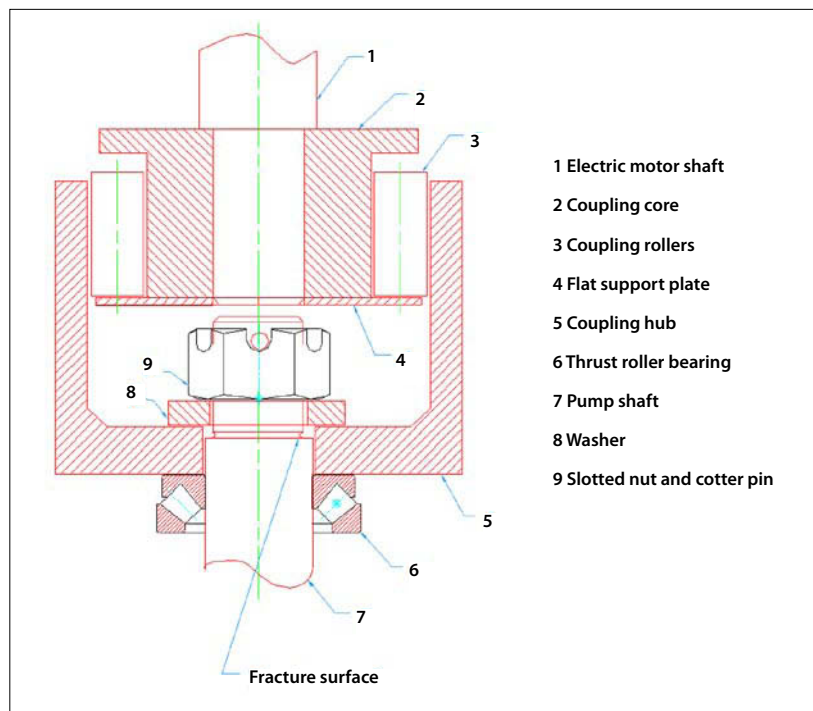
Figure 1. Sketch of the shaft ends with coupling and thrust bearing.

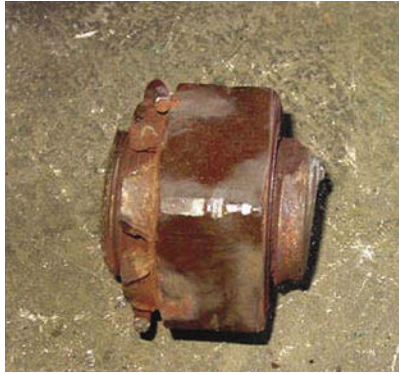
As in every fatigue failure, the breakdown occurred suddenly and nothing could be done to prevent the damage to the internal parts of the pump. The fracture was located in a change of section in the shaft under the coupling hub (Figures 1 and 2), and the appearance of the fracture surface suggested the presence

Figure 2. Location of fatigue fracture in a change of section on the pump shaft.

The load causing the failure is assumed to be the bending stress caused by the actual angular misalignment being larger than that allowed by the over-running clutch coupling. The original motor support frame had been replaced and it is possible that a slight dimensional difference caused misalignment. Maintenance engineers ought to have recognized the additional care required by this type of coupling during alignment and demanded more accurate work from the maintenance operators and the use of more precise tools for the job. The change of section on the shaft behind the thread is the fully loaded stress raiser nearest to the load application point, the rest of the pump shaft being very smooth.

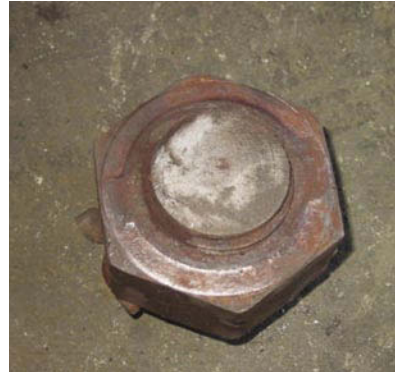
Figure 3. Appearance of pump shaft fatigue fracture surface.

of symmetric bending stress in rotation acting over a low stress concentration factor at a moderate cyclic load (Figure 3).

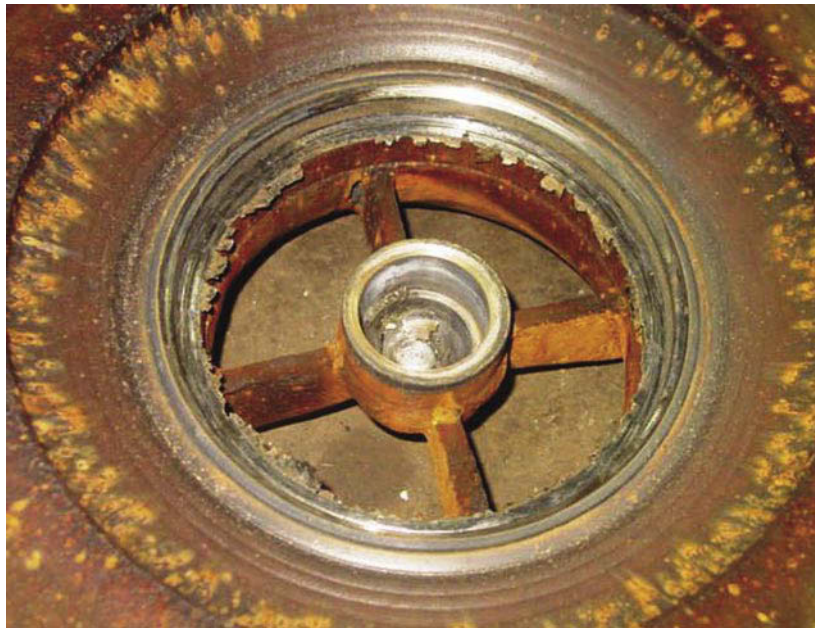
Figure 4. Damage to first-stage casing, wear ring and bottom bush.

After the failure of the shaft, the coupling hub and the thrust bearing inner ring are free and the whole pump rotor is also free to move downwards, while still rotating at high speed, until it collides with the pump first-stage casing and bottom bush. Damage to the first-stage casing, first-stage casing wear ring and bottom bush are shown in Figure 4, while Figure 5 shows the damage to the first-stage impeller front shroud and wear ring.

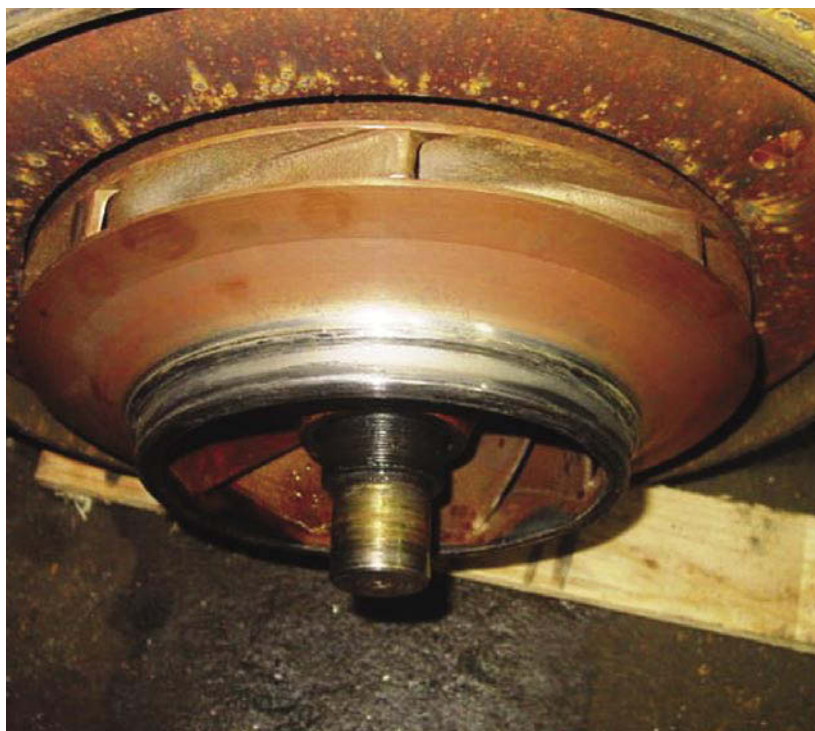
Figure 5. Damage to first-stage impeller front shroud and wear ring.

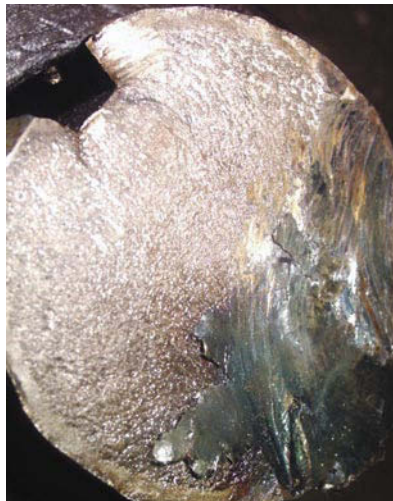
As with the twin pump, it is inferred that the load causing the failure arises from the actual angular misalignment exceeding that allowed by the over-running clutch coupling. As was the case with the first pump, the motor support

frame had been replaced. The stress concentration factor this time is the corner of the keyway, where the crack clearly starts (Figure 6).

Figure 6. Fracture location on the motor shaft immediately behind the coupling core.

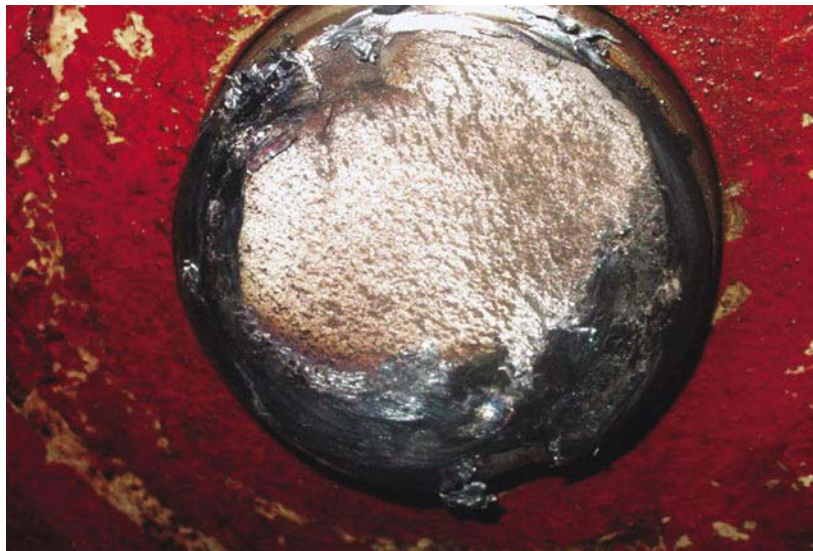
This case also occurred on a vertical condensate extraction pump using an old design of over-running clutch coupling. The pump involved was in fact a 'twin' to that discussed in the previous case study. This time the fracture was located not on the pump shaft but on the motor shaft immediately behind the coupling core (Figure 6). As in the previous case study, the appearance of the fracture surface suggested the presence of symmetric bending stress in rotation acting over a low stress concentration factor at a moderate cyclical load (Figure 7).

Figure 7. The fatigue fracture surface of the motor shaft.
